**Update on the Clean-up Following the Accident
at a Fuel Storage of Norilsk Nickel**

July 13, 2020

Accident Overview

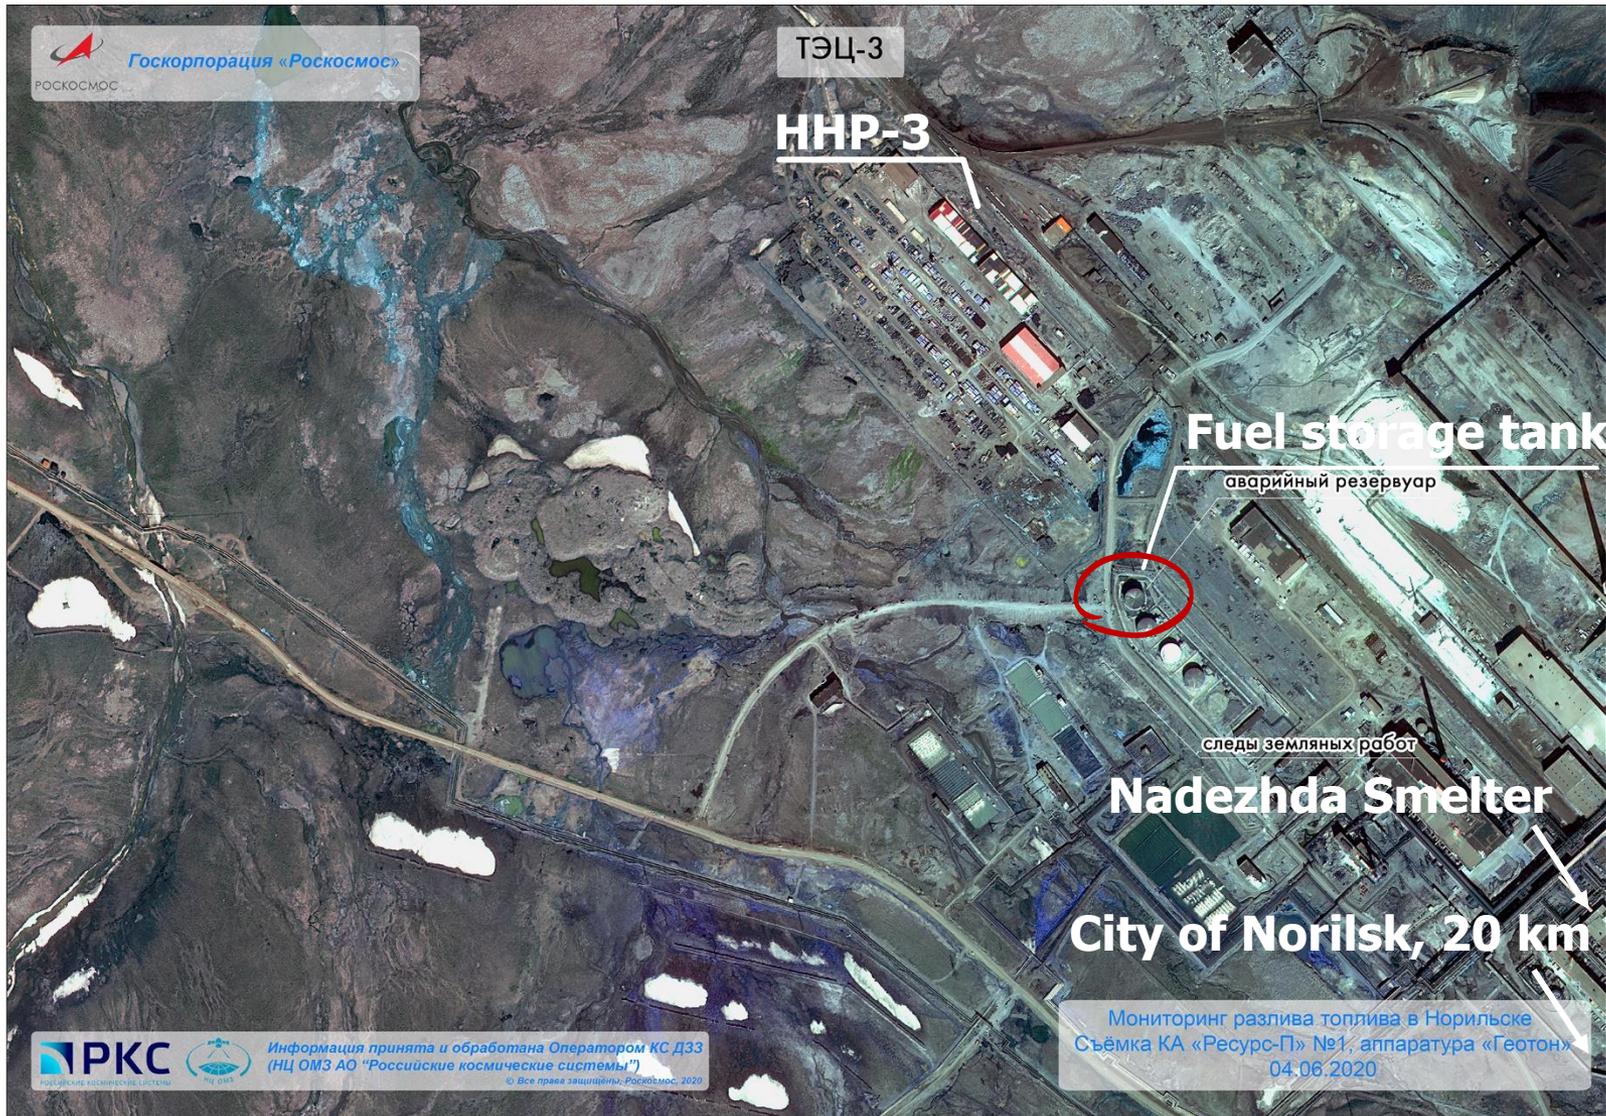
ROSKOSMOS Satellite Images of HHP-3 and Damaged Fuel Tank

- On May 29, 2020, an accident occurred whereby the containment of the emergency fuel storage at Heat and Power Plant № 3 (HPP-3) in the Kayerkan neighborhood of Norilsk failed due to sudden sinking of support posts, resulting in the fuel leakage

- According to the Company's assessment, the accident could have been caused by the thawing of permafrost which resulted in sinking of support posts
- Since the HPP-3 is located remotely from Norilsk, the city has not been impacted

- Over a short period of time, 21.2kt of diesel fuel has leaked beyond the bunding perimeter into a designated pit and partially into the Bezymianny stream

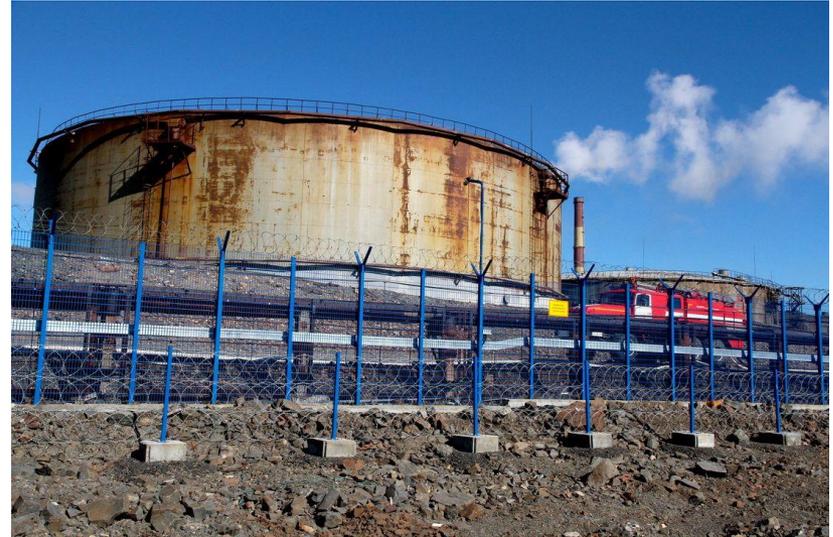
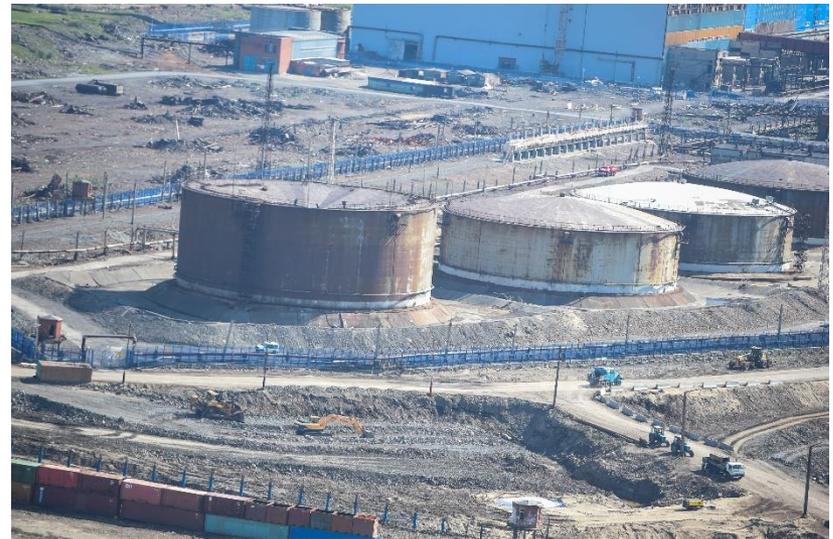
- HPP-3 is operated by Norilsk Nickel's wholly-owned subsidiary, Norilsk Taymir Energy Company (NTEC)
- HPP-3 predominantly serves the local municipality of the Norilsk Industrial District and supplies some power to Norilsk Nickel's facilities
- HPP-3 consumes natural gas, with diesel fuel used only in emergencies and stored in fuel reservoirs
- The reservoir #5, where the accident took place, was built in 1985
- After undergoing repairs in 2017-2018, the reservoir #5 went through hydraulic testing and Industrial Safety Audit (ISA) in 2018
- All recommendations of ISA regarding filling the reservoir #5 for the first time after the repairs were followed and controlled

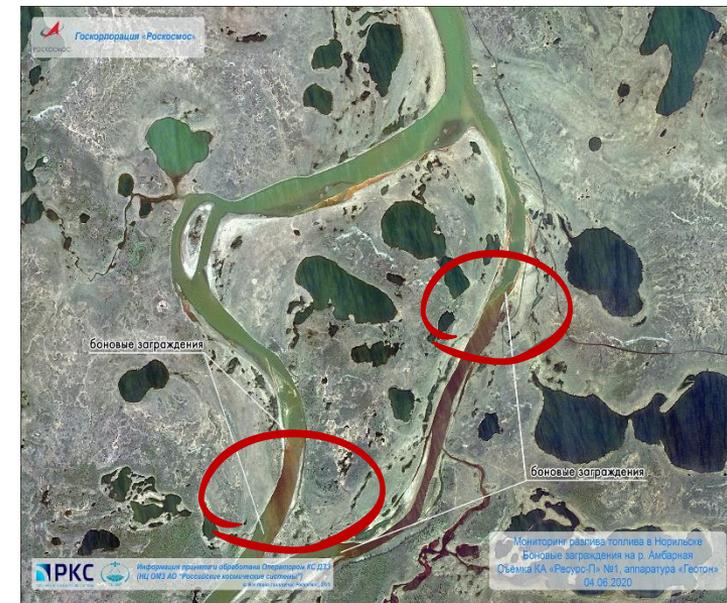
- **Satellite images published by Roskosmos on June 4th confirm that the oil spills were well contained in the Ambarnaya river**

- **Special containment booms have been installed in the Ambarnaya River**, which have prevented the spill from spreading to the downstream Pyasino Lake, including 40 lines of conventional containment booms and 79 lines of absorbing booms
- The spill has not reached Pyasino Lake
- There is no risk of pollution of the Kara Sea
- Regular aerial monitoring of the impacted area is carried out

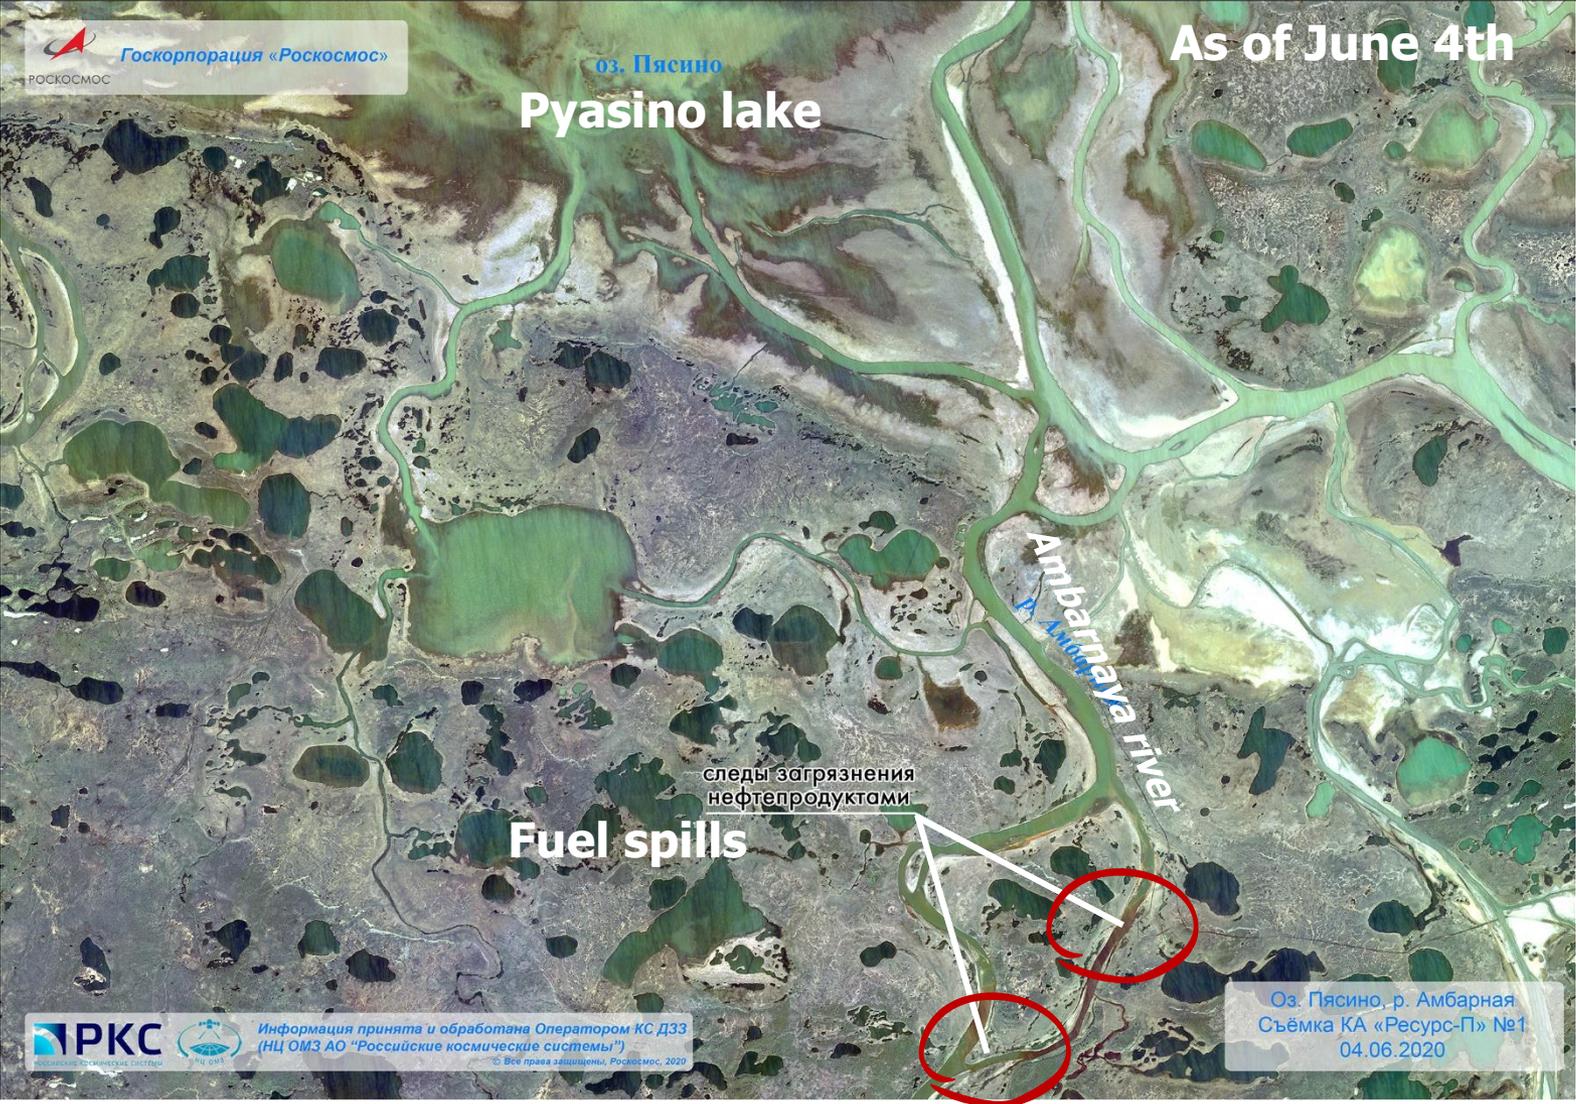
ROSKOSMOS Satellite Images of Norilsk-Pyasinsky Water System

- The fuel spill through Bezymianny stream via Daldykan river reached Ambarnya river, where boms prevented the contamination of Pyasino lake
- The exact distribution of the contamination will be assessed through the soil recultivation, pumping out of the fuel from the pit and drain sumps, and cleaning of water

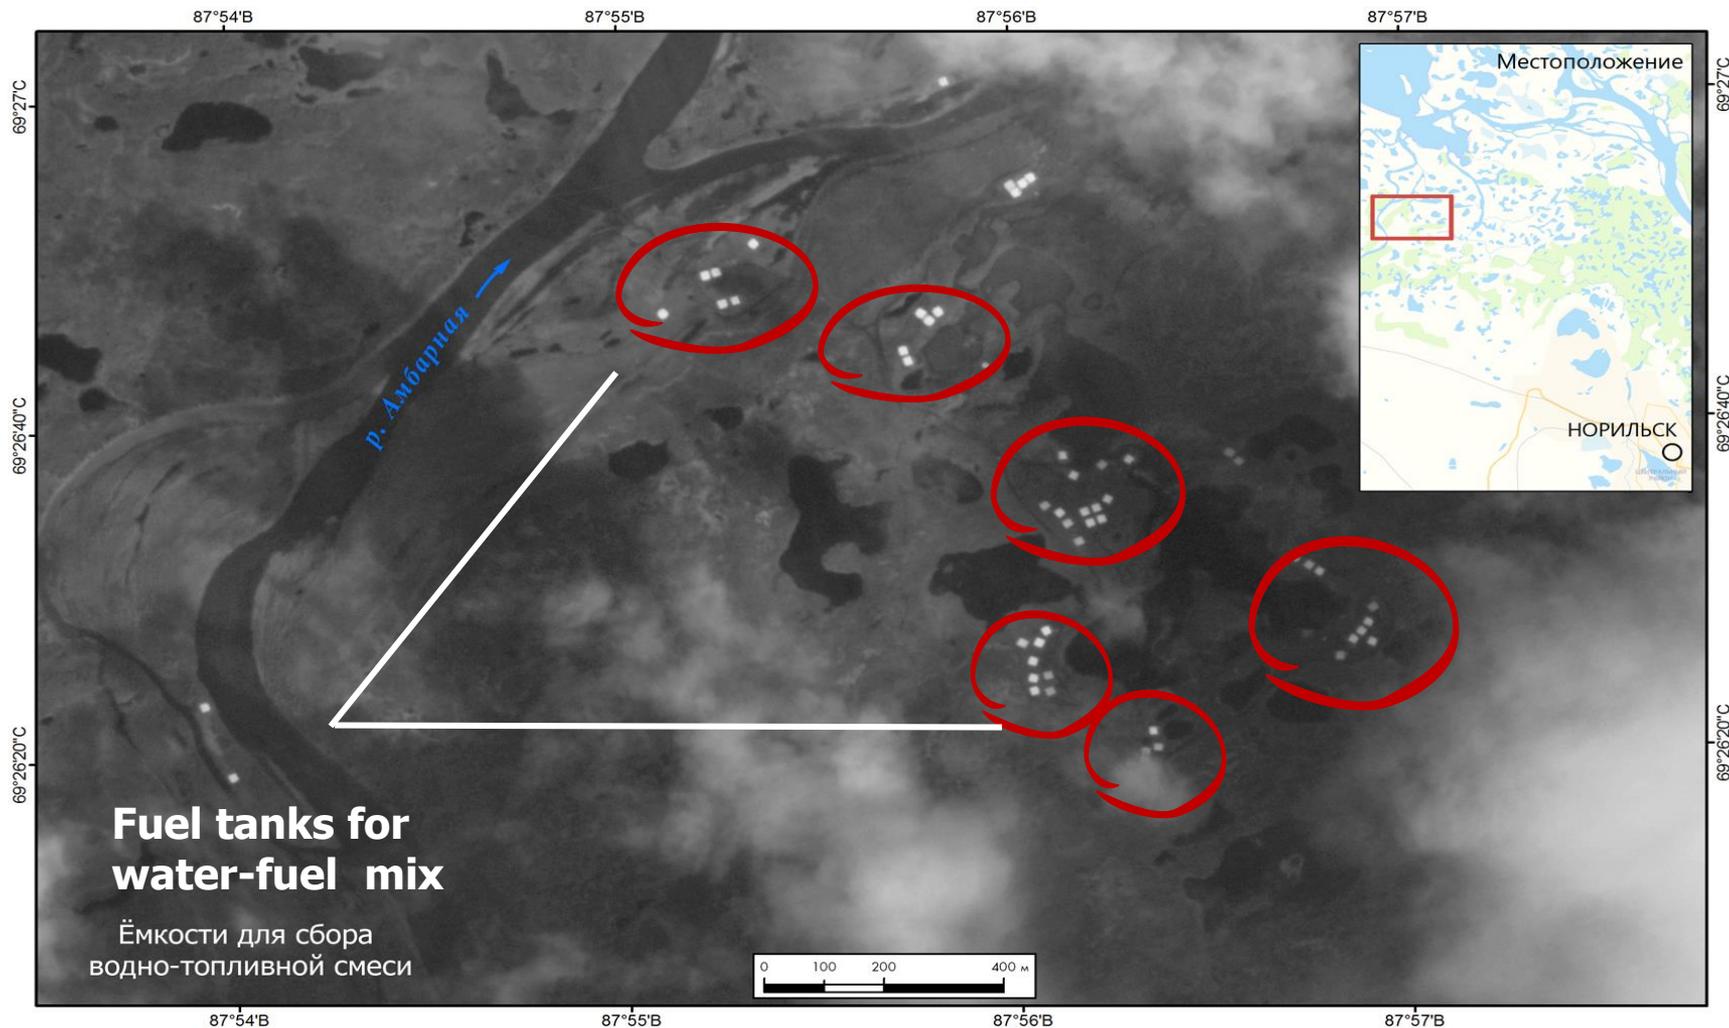
ROSKOSMOS Monitoring of the Cleanup Progress as of June 15th

МОНИТОРИНГ ЛИКВИДАЦИИ ПОСЛЕДСТВИЙ РАЗЛИВА ТОПЛИВА. РОССИЯ, КРАСНОЯРСКИЙ КРАЙ, ДОЛГАНО-НЕНЕЦКИЙ АО
ПО ДАННЫМ КА "КАНОПУС-В" №4 / ПСС 15.06.2020
